SEDIMENTATION SURVEY OF GREENBELT LAKE

GREENBELT, MARYLAND

January 27 - February 8, 1938

SCS-SS-33

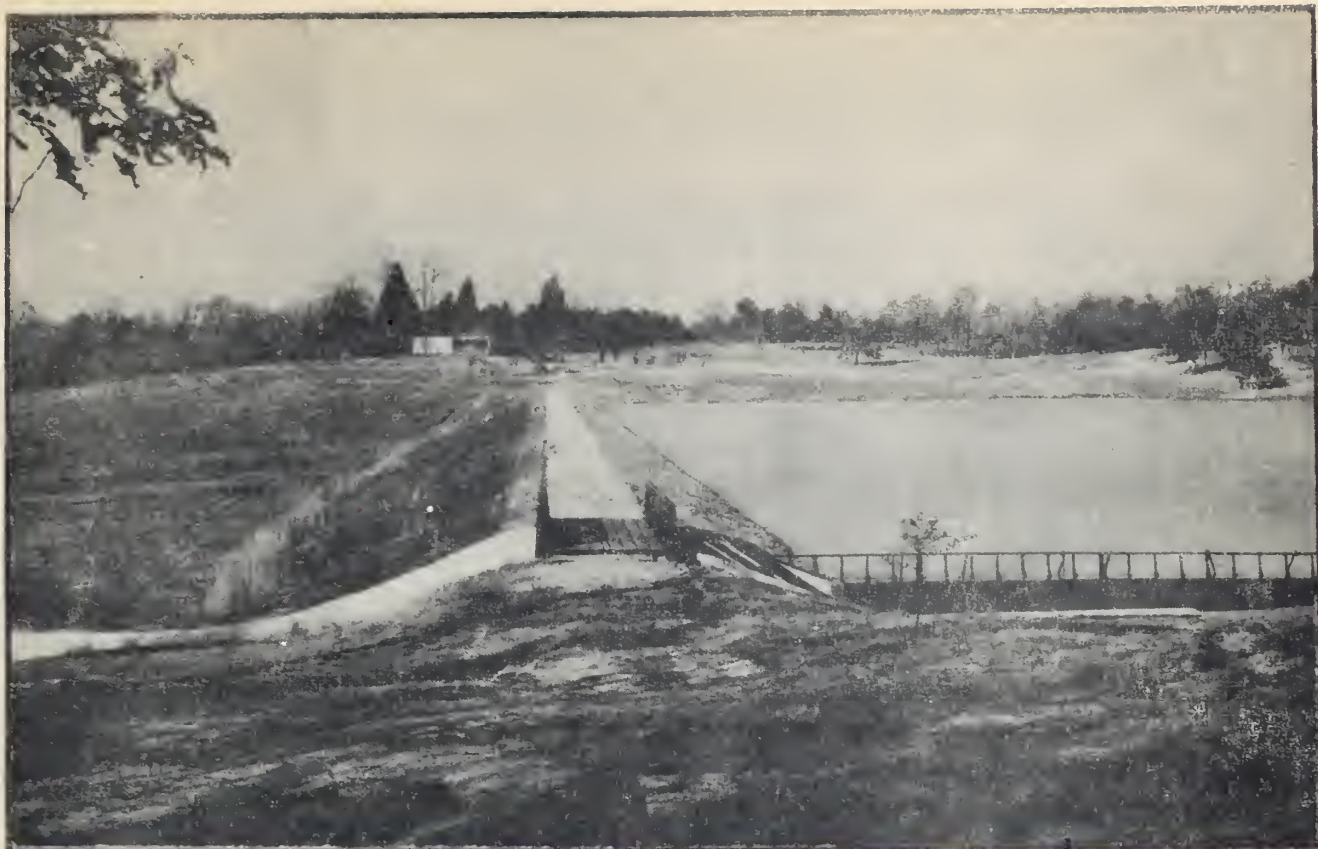
Figure 2.--View of Greenbelt Dam, showing the vine and grass covered downstream face, the riprapped water face, and part of the spillway.

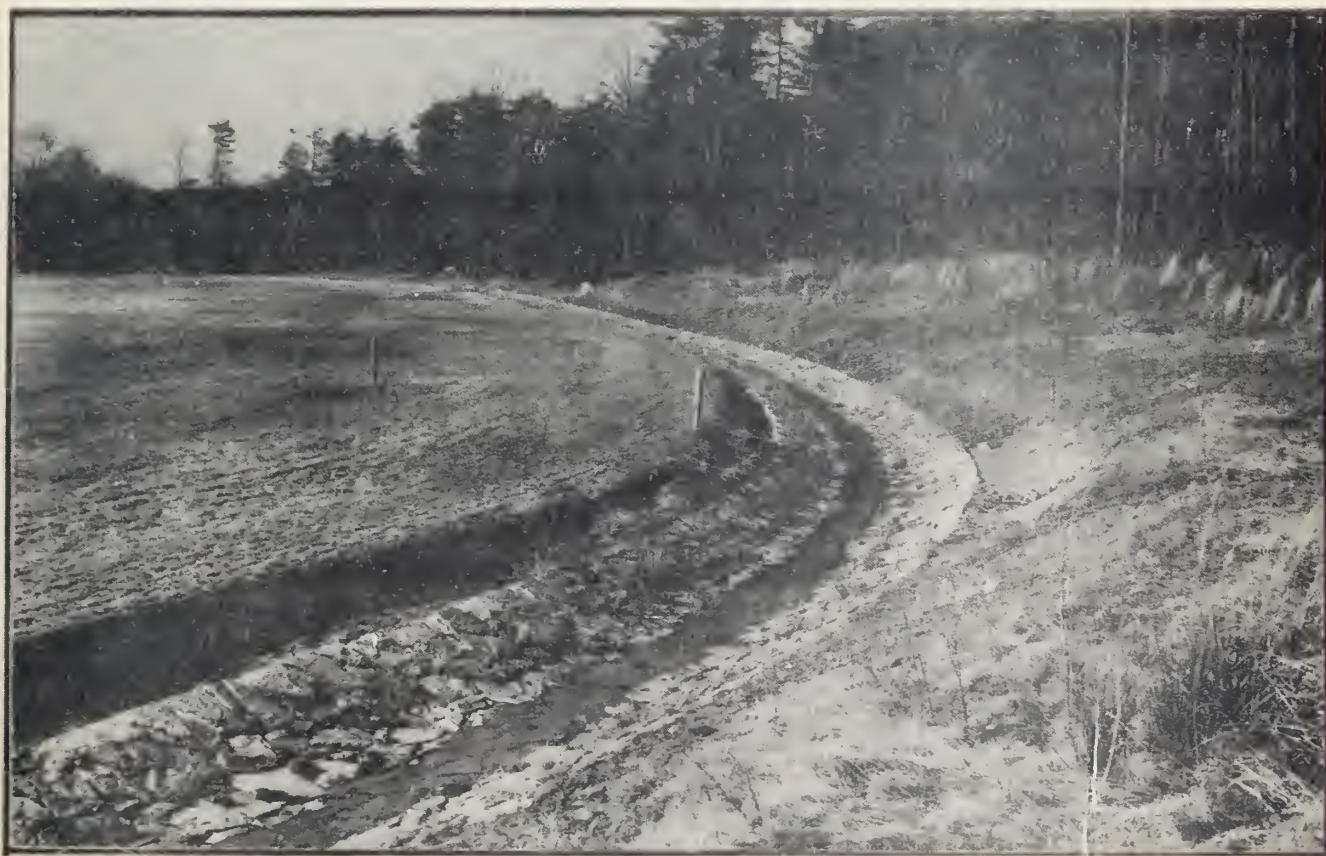
Figure 3.--View of the rock-lined channel of the stream draining the town of Greenbelt. The rock pavement, although effectively preventing further down cutting of the channel, was not built far enough up the sides to prevent bank scouring by flood discharges.

By the end of 1938 much progress had been made in reducing excessive erosion in the Greenbelt development. All the main drainage channels had been lined with loose rock pavement (fig. 3, following p. 3), thereby greatly reducing channel erosion. Some bank scouring has occurred above the edges of the pavement, however, and at one place, about 600 feet above the head of the lake, a section of the channel that receives the discharge from most of the storm sewers in Greenbelt has been stripped of its rock lining on two occasions by the sudden floods that follow even moderate rains. This section of channel is now being repaired permanently by grouting the rock in place with cement.

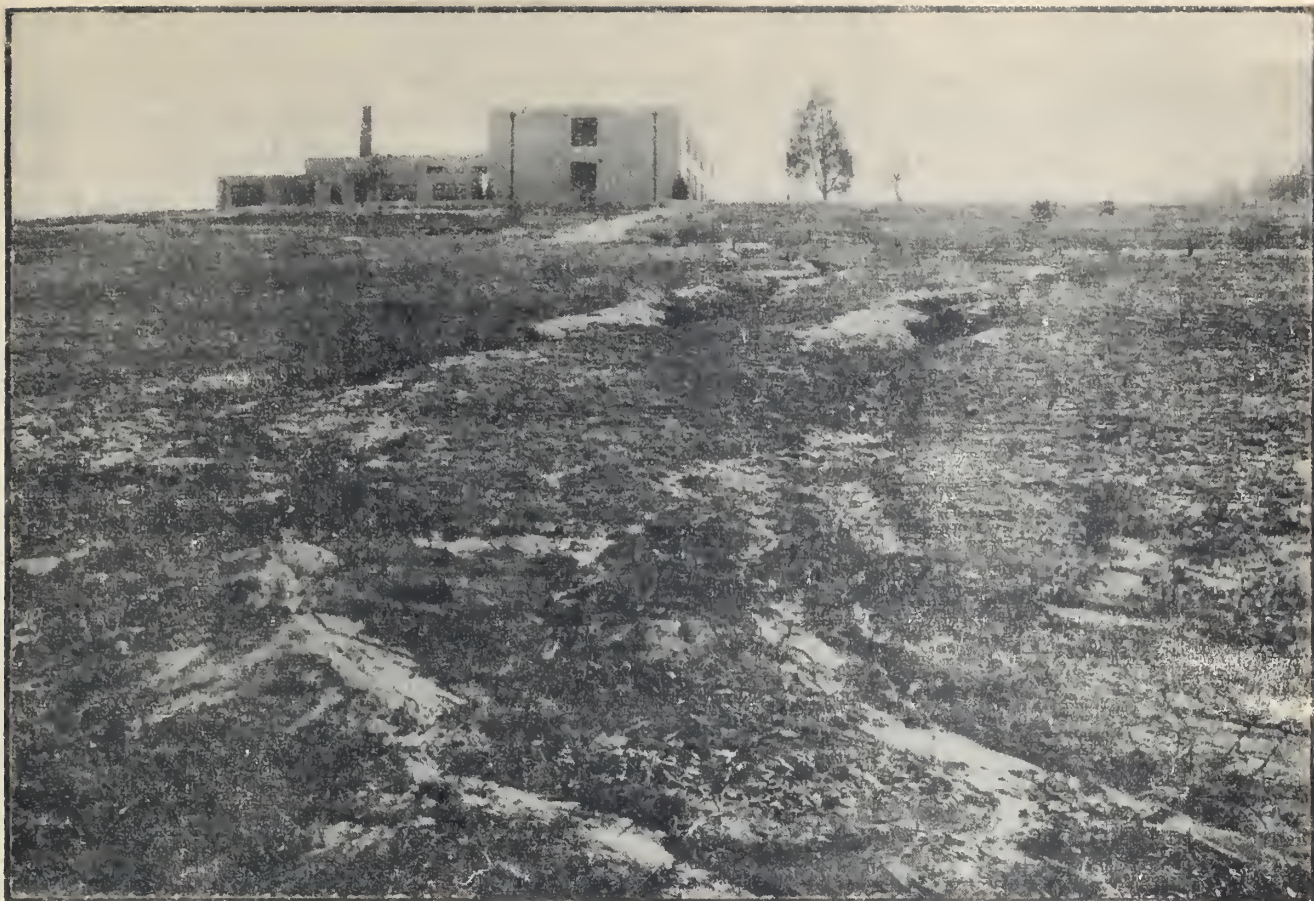
Two areas, one a field just south of town and the other the slope just west of the community center (fig. 5), were still exposed to excessive erosion in January 1939 but were scheduled for application of topsoil cover and sodding.

Figure 5.--View showing gully erosion of bare slope just west of the town of Greenbelt.

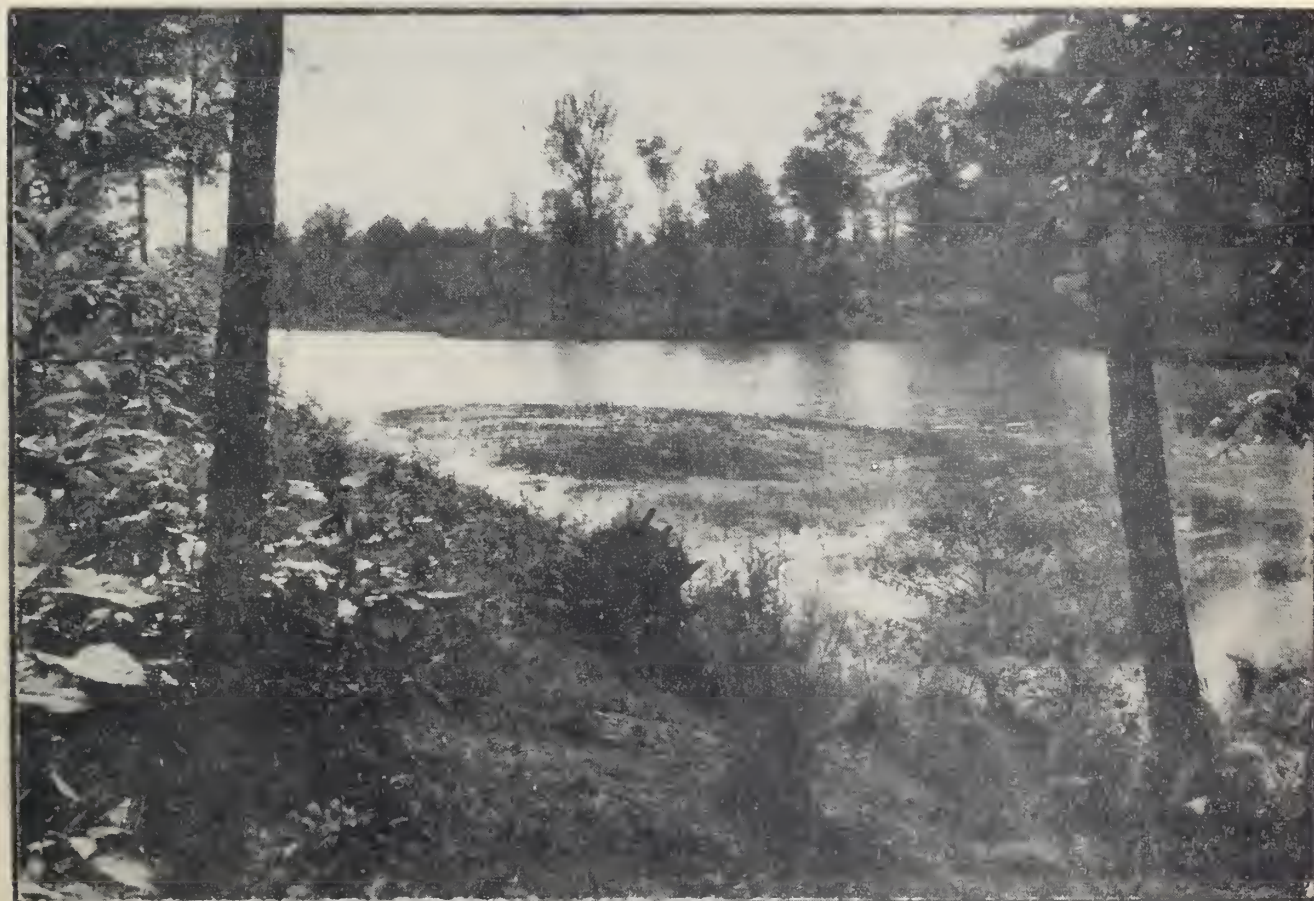
Figure 6.--View of delta at the head of Greenbelt Lake.

The bulk of the sand in the lake was deposited in the form of a delta (fig. 6), which had a flat upper surface a few inches above crest level and an abrupt frontal slope. This delta lies at the mouth of the southernmost of the two streams that enter the lake at its head and is the only visible evidence of excessive silting in the lake. At the time of survey it was about 250 feet long, 60 feet wide, and more than 5 feet in maximum thickness. Only a very small deltaic deposit, estimated to be 15 feet wide, 40 feet long, and 1 foot in maximum thickness, had formed at the mouth of the north feeder stream by January 1939. The contrasting size of these two deposits is a striking indication of the relative importance of the areas tributary to the two streams as sources of sediment.

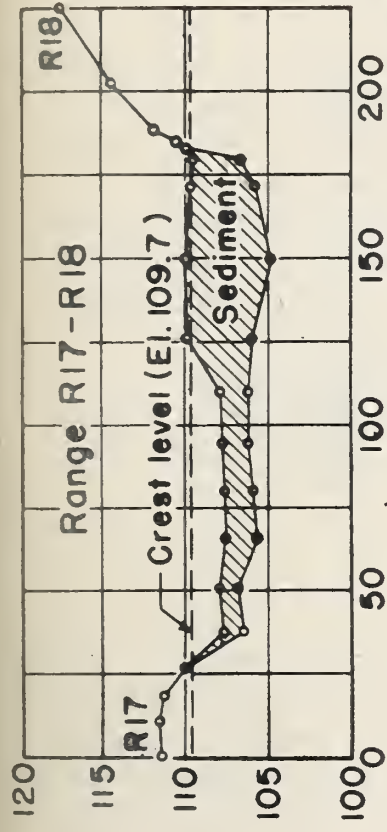
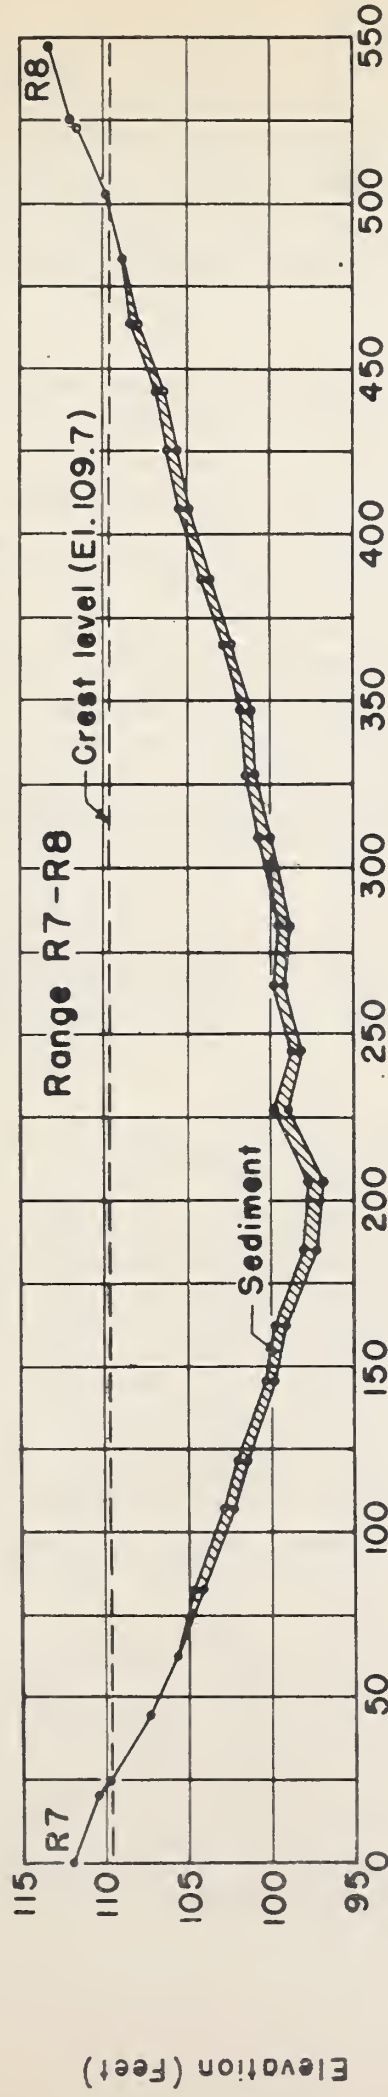
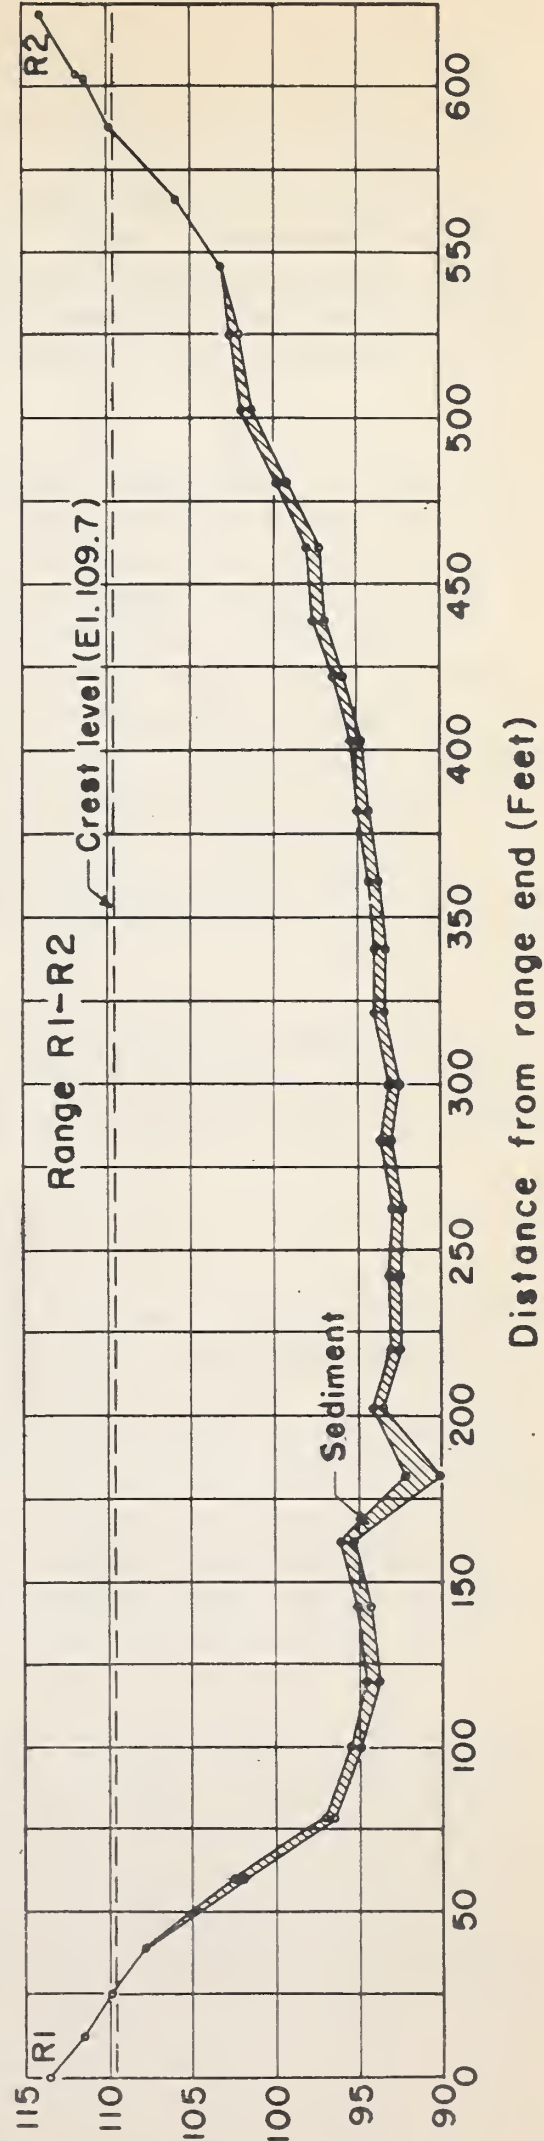
Figure 7.-Representative cross sections of Greenbelt Lake.

The deposits in Greenbelt Lake were characterized by strikingly uniform distribution over the basin as a whole, the only notable variation in thickness occurring in the delta area at the head of the main arm. The dominantly silty deposits below range R15-R16 extended over the basin floor as a uniform blanket, generally about 5 inches thick but thinning out gradually up the submerged valley slopes (fig. 7).

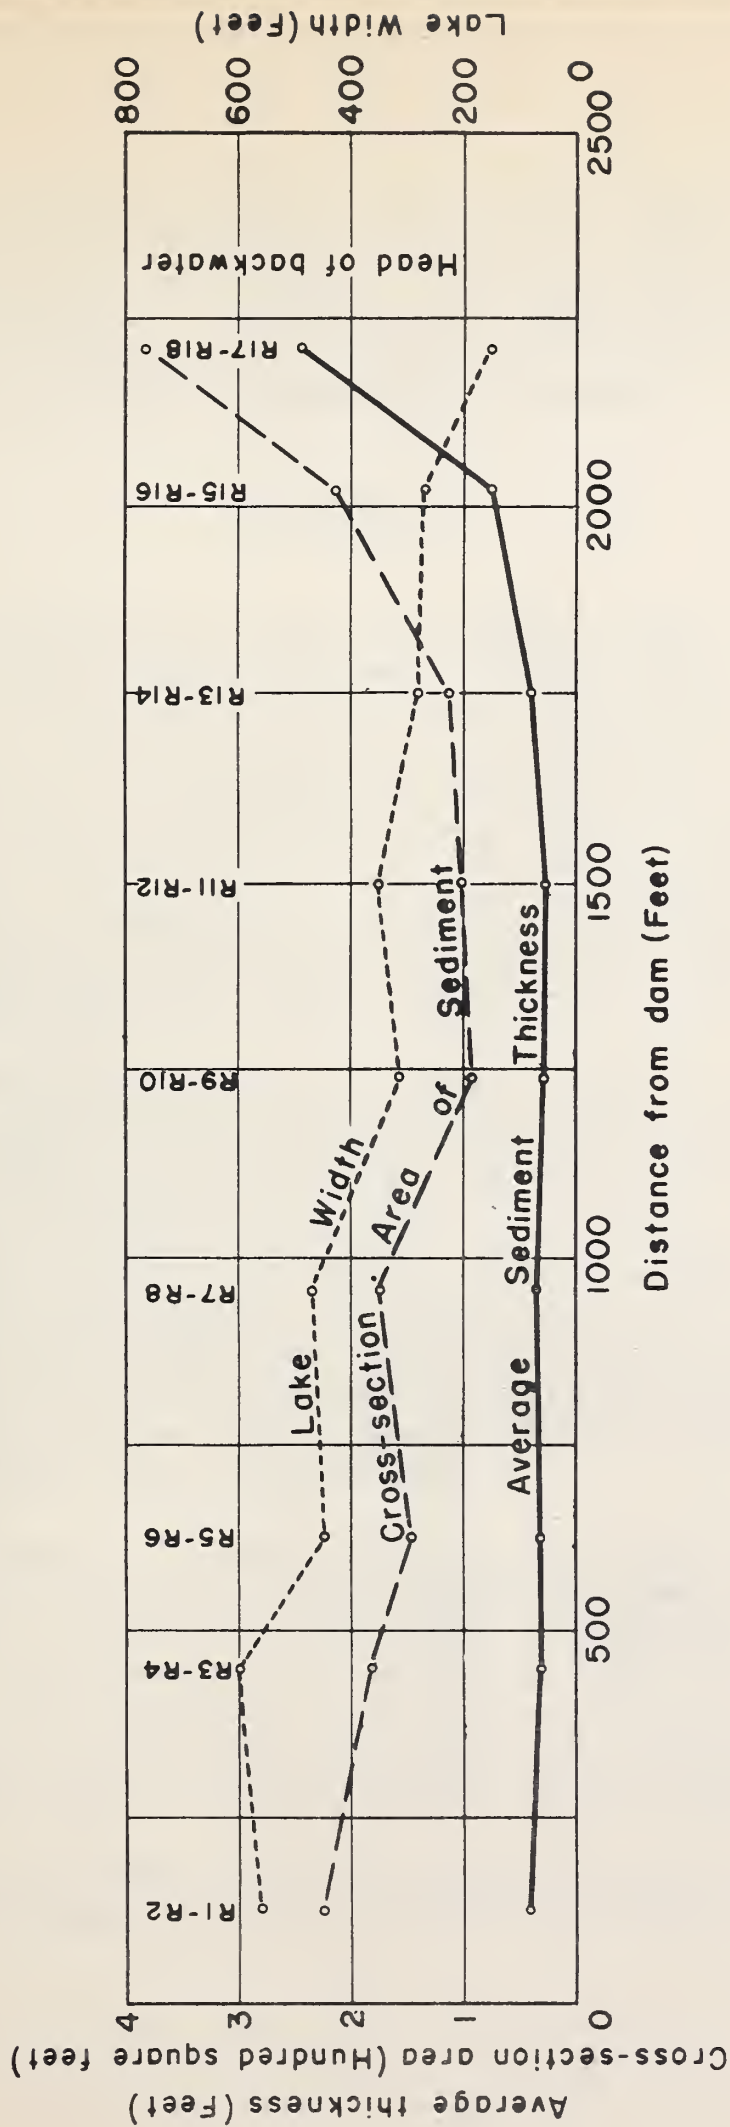
Figure 8.-Distribution of sediment in Greenbelt Lake.

The average sediment thickness (computed by dividing the cross-section area of the deposit on each range by the lake width) remained almost constant between 0.3 and 0.4 foot from the dam to range R13-R14 (fig. 8), above which it increased to a maximum of 2.4 feet on range R17-R18, just below the head of backwater. The sediment attained maximum thicknesses of 5.2 feet on range R17-R18 (fig. 7), 2.1 feet on range R1-R2, just above the dam, and 1.4 feet on range R15-R16. The maximum thickness on all other ranges was less than 1 foot.

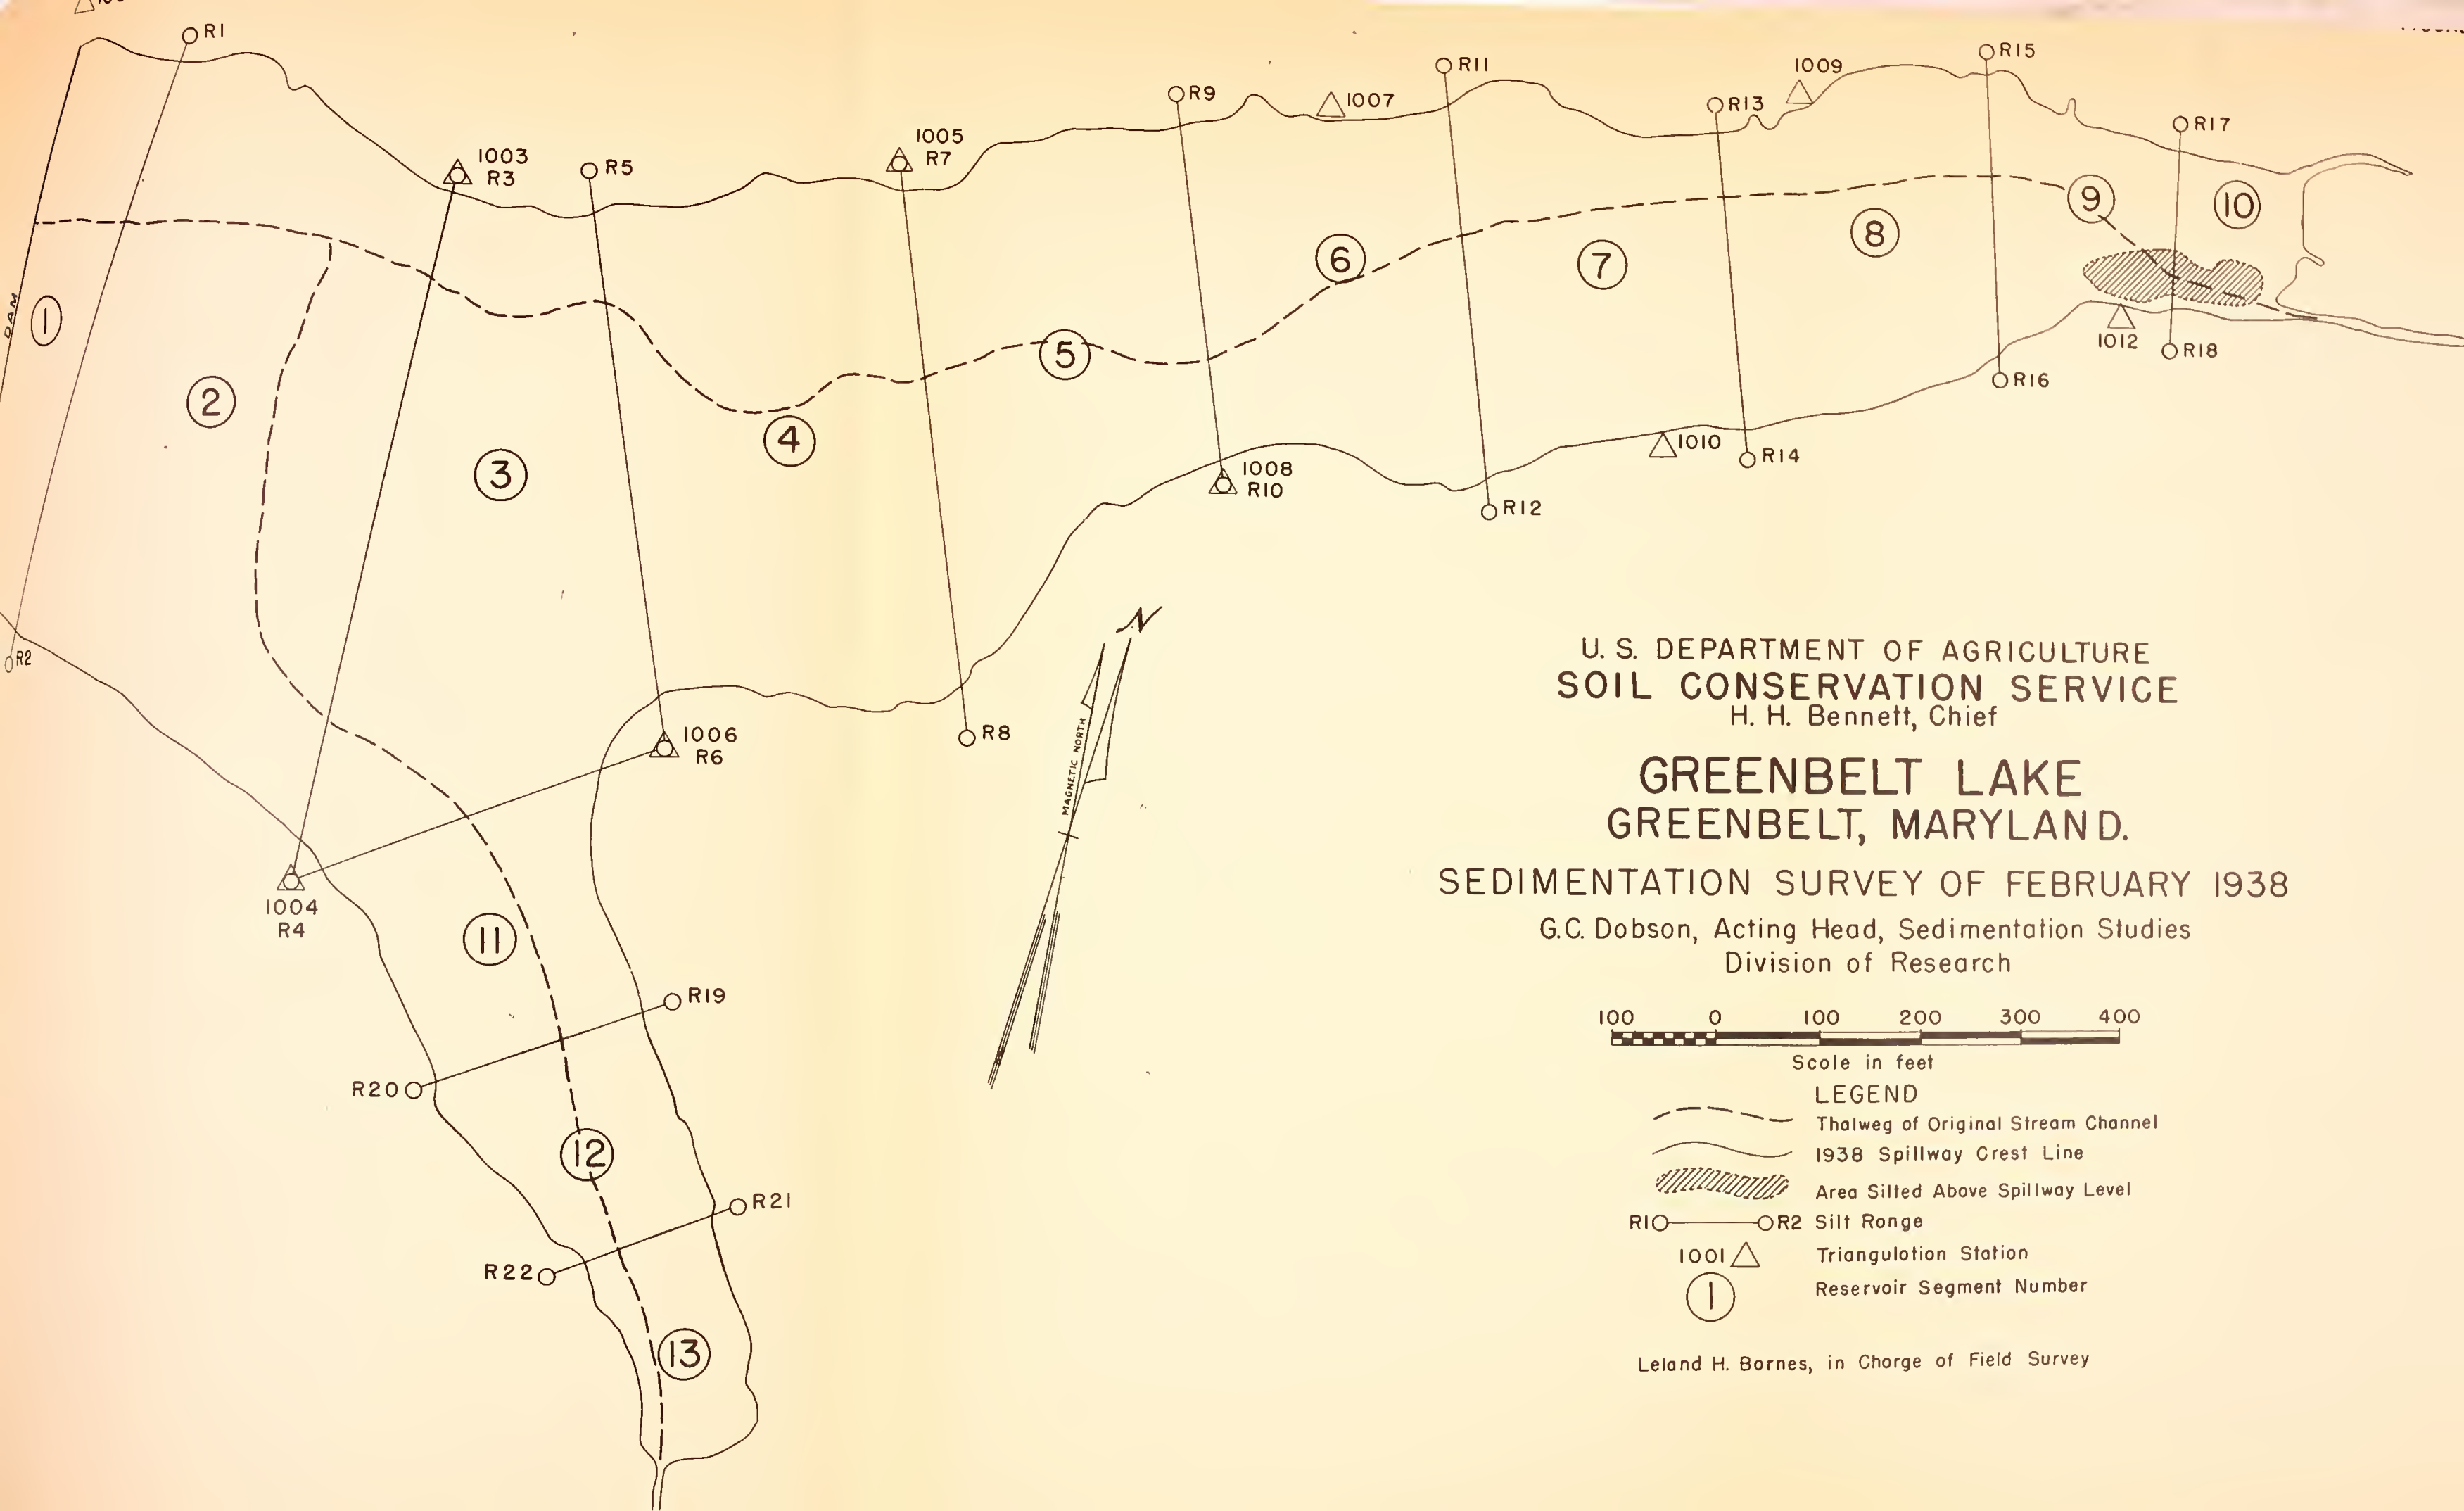
In the lower part of the lake the deposits consisted of rather even-textured soft reddish-brown silt and minor amounts of clay and fine- to medium-grained sand. The sediment was distinctly sandy only in the upper part of the lake, above range R13-R14 (fig. 4), and there the sand was confined largely to an elongated bar on the south side of segments 9 and 10. This bar was composed principally of brownish-gray medium- to coarse-grained clean sand, although some organic matter, mainly leaves, had accumulated in a few small interbedded lenses.
